Conservation of a Standing Male Sculpture (Athlete)

Report of Constantinos Vasiliadis
SKD Research Fellowship 2015
(24 Oct. – 22 Nov. 2015)

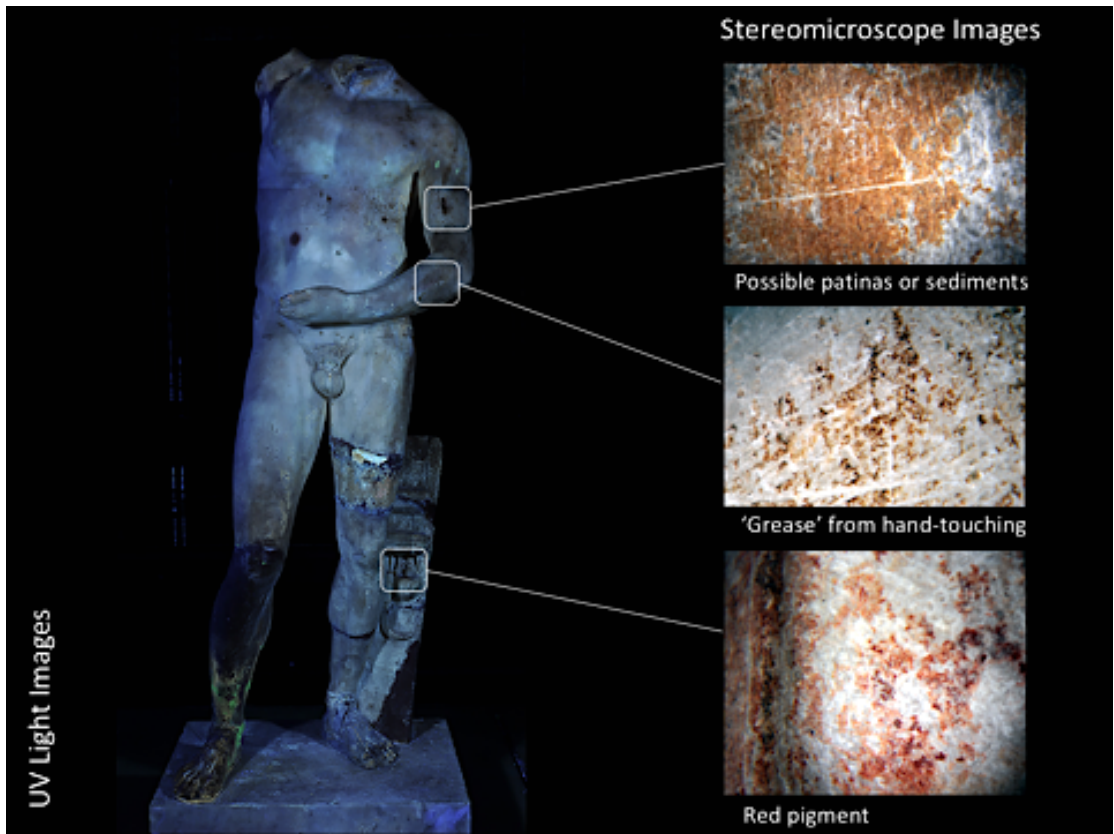
UV Light Image showing the condition of the statue in combination with Stereomicroscope images.

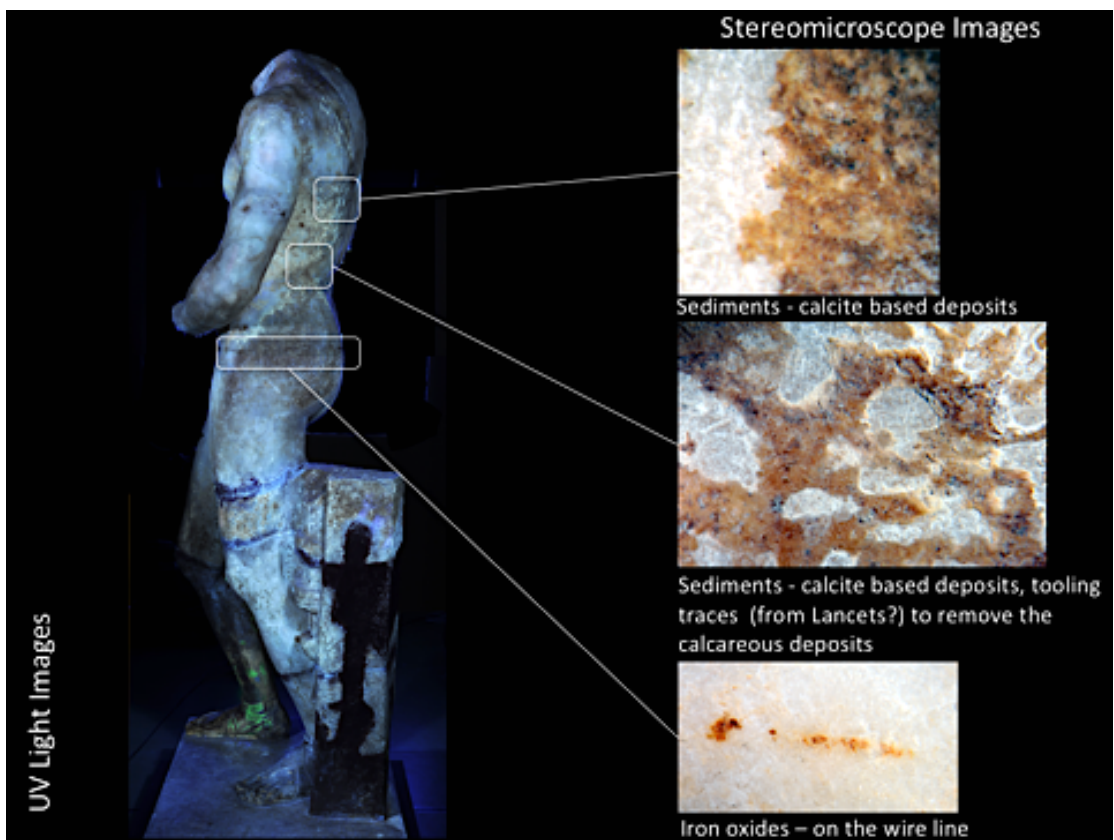
UV Light Image showing the condition of the statue in combination with Stereomicroscope images.

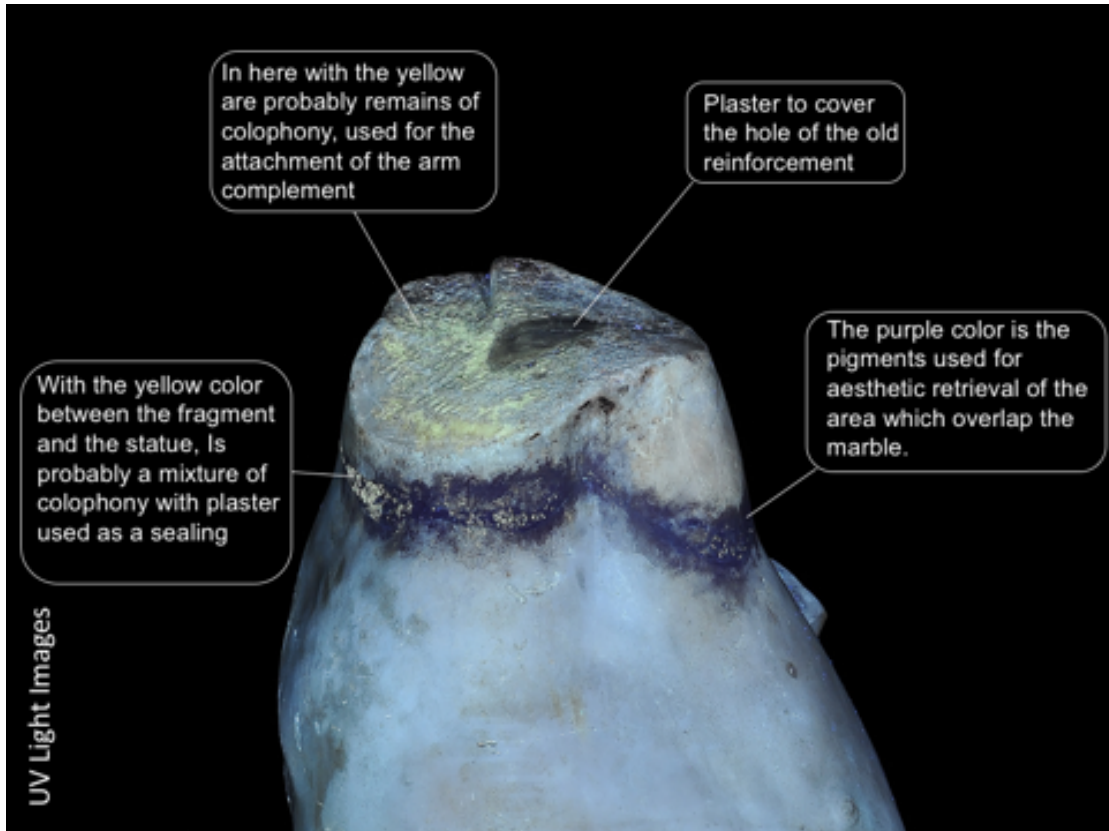
UV Light image with notes on the materials from previous interventions

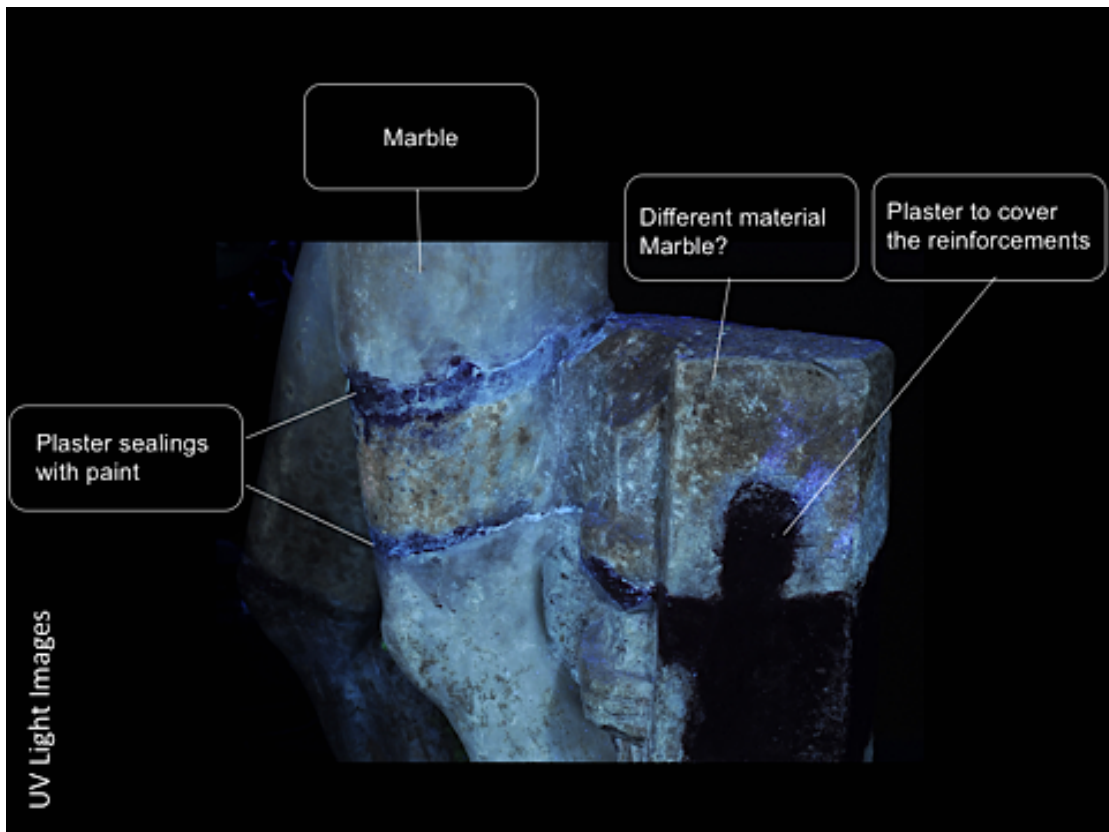
UV Light image with notes on the materials from previous interventions

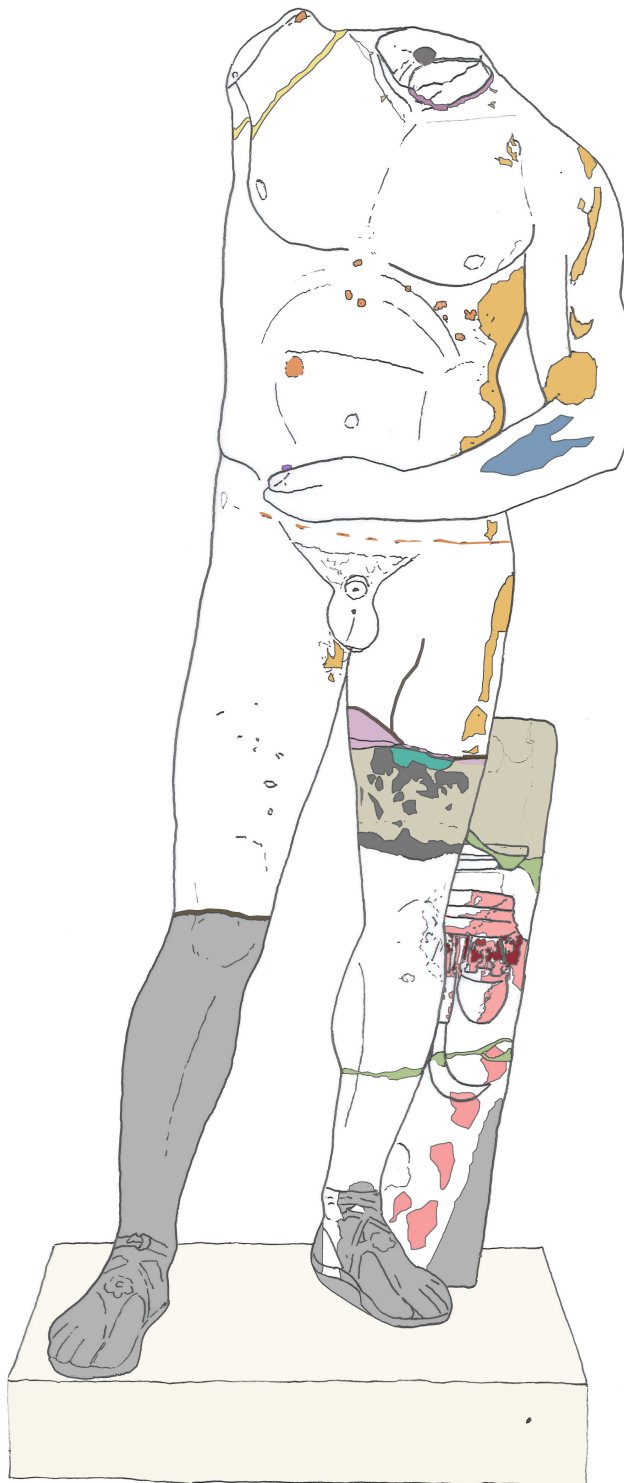
Mapping drawing of the front side

- Calcite based deposits from the burial environment, there is a possibility to have underneath remains of the sculpture's polychromy.
- Grease from touching.
- Iron oxide stains.
- Areas with possible oxalate patinas, or also remains of the calcite based deposits.
- Red pigment.
- Cracks.
- Plaster complements.
- Stone-marble complements.
- Sealings with plaster (1).
- Sealings with different kind of plaster (2).
- Sealings with colophony based material, or remains of it.
- Sealings with cement, probably sorel cement
- Recent loss of sealling
- Remains of asphalt(?)
- Remains of Shellac(?)
- Remains of other resin(?)
- Marble base

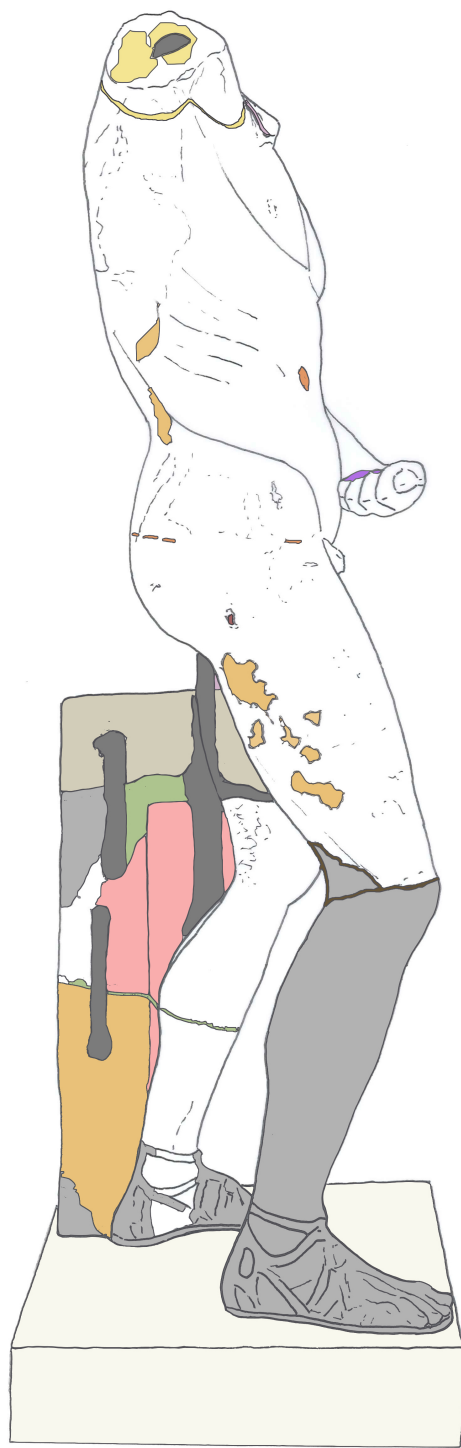
Mapping drawing of the right side

- Calcite based deposits from the burial environment, there is a possibility to have underneath remains of the sculpture's polychromy.
- Grease from touching.
- Iron oxide stains.
- Areas with possible oxalate patinas, or also remains of the calcite based deposits.
- Red pigment.
- Cracks.
- Plaster complements.
- Stone-marble complements.
- Sealings with plaster (1).
- Sealings with different kind of plaster (2).
- Sealings with colophony based material, or remains of it.
- Sealings with cement, probably sorel cement
- Recent loss of sealling
- Remains of asphalt(?)
- Remains of Shellac(?)
- Remains of other resin(?)
- Marble base

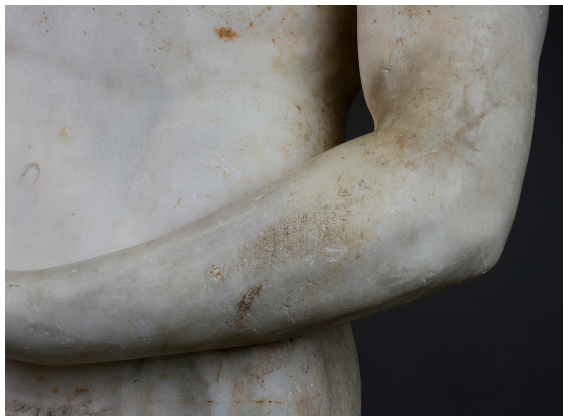
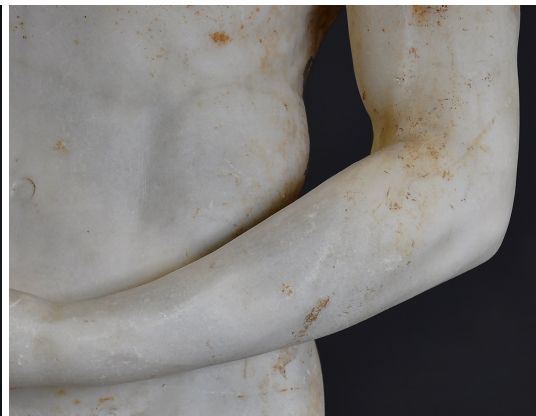
- There is an 'oily' stain from the touching of the statue by the visitors, on the lower part of the left arm.
- There is a dark stain (resin or asphalt?) on the right armpit.

Removal of grease from the left arm with water- compress and sponge.

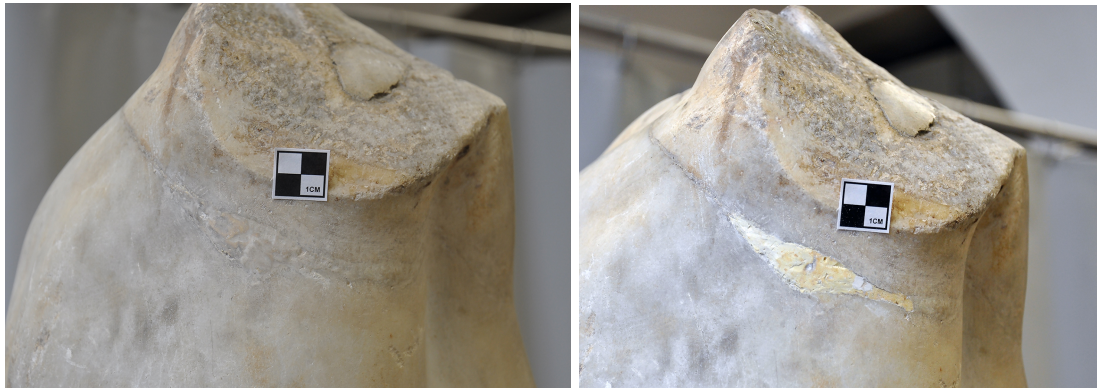
Right armpit: removal of paint with sponge and water. A mixture of Colophony with plaster used for sealing, has revealed.

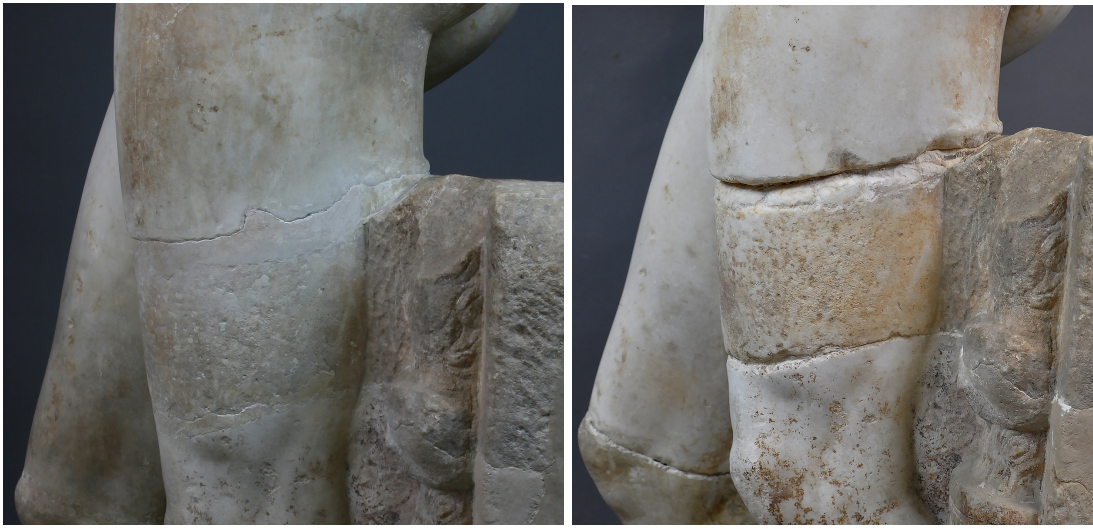
In other areas such as these of the left leg, under a thin plaster layer, there was a hard cement filling. Probably it is Sorel Cement. Before removing the cement with lancet, the area was covered with compress with water to soften.

Left leg: Before and after the removal of the plaster and cement (Sorel?) sealing

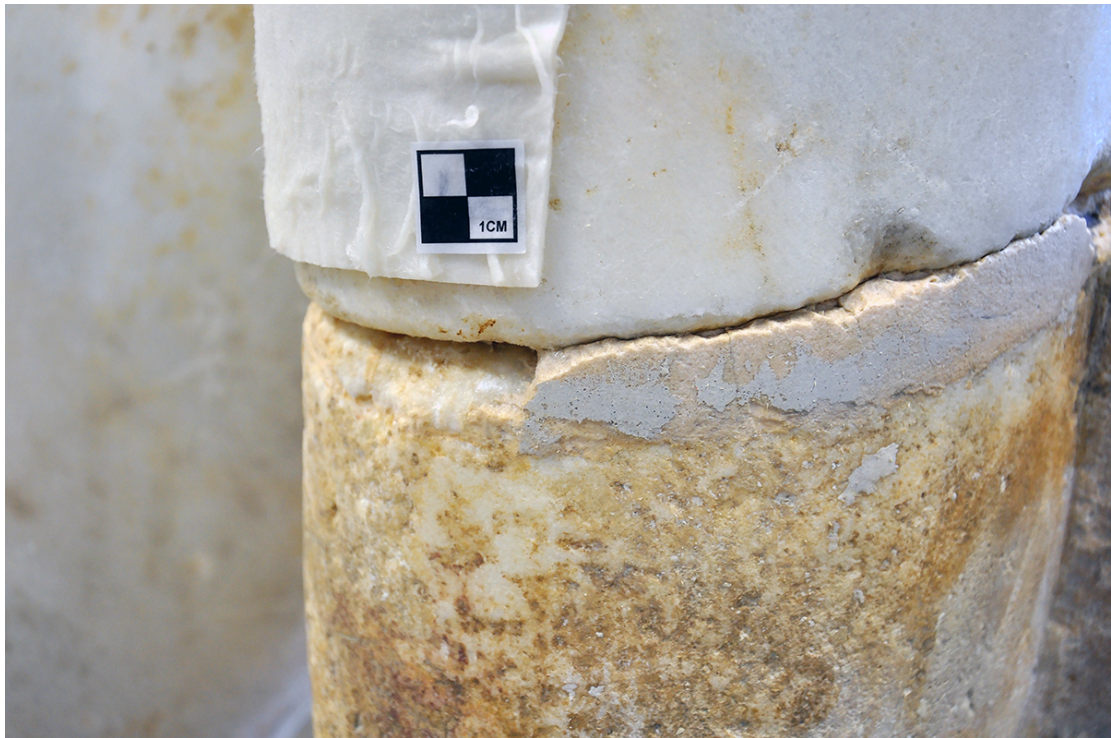
Detail of the left leg during the removal of the plaster and cement (Sorel?) sealing

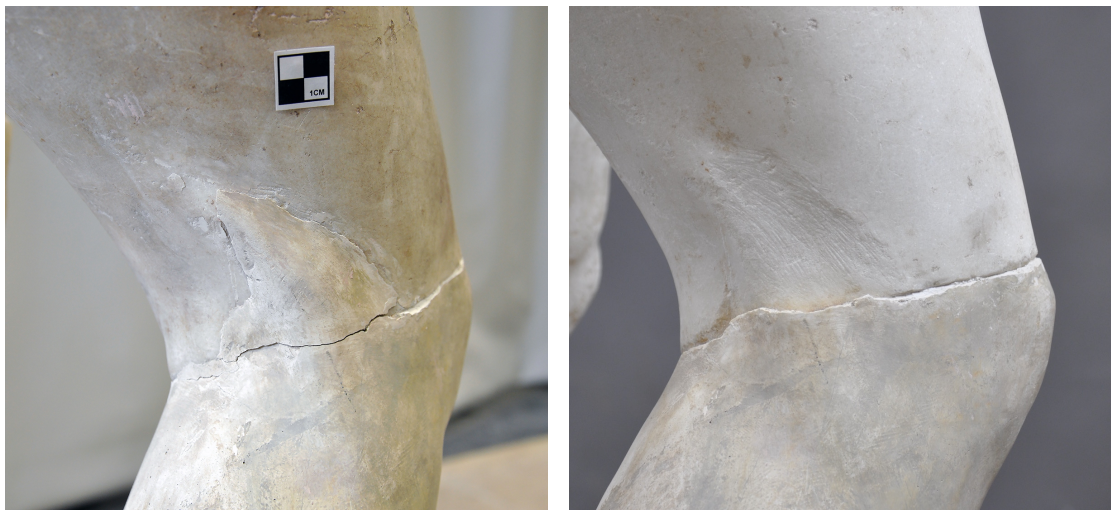
Right leg: Reveal of marble surface, elaborated with rasp. under the plaster complement

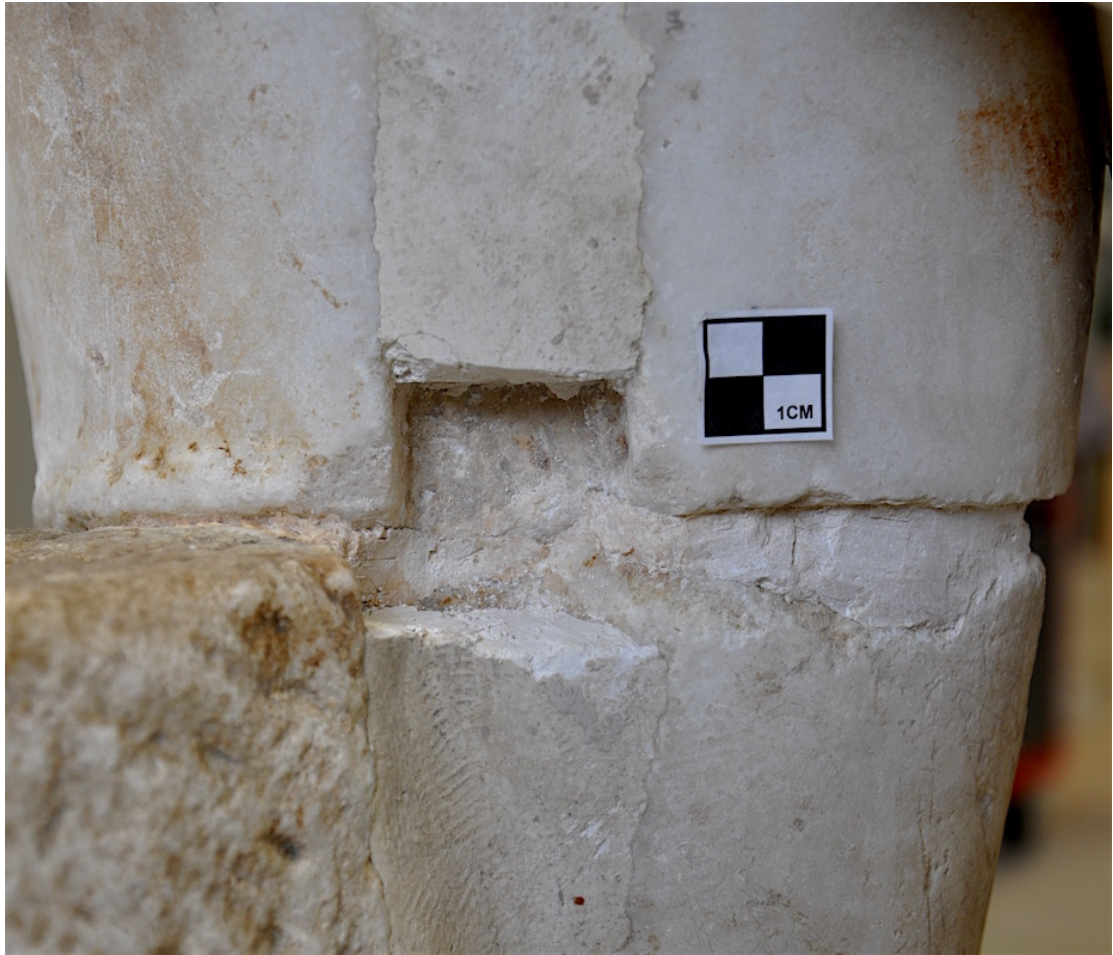
Detail of the back side of the left leg, with the empty mortise

During sealing removal on the left leg, it was found that the mortise, opened to accommodate a dowel, during previous intervention was empty. So probably these type of dowels removed during the restoration of G. Treu.

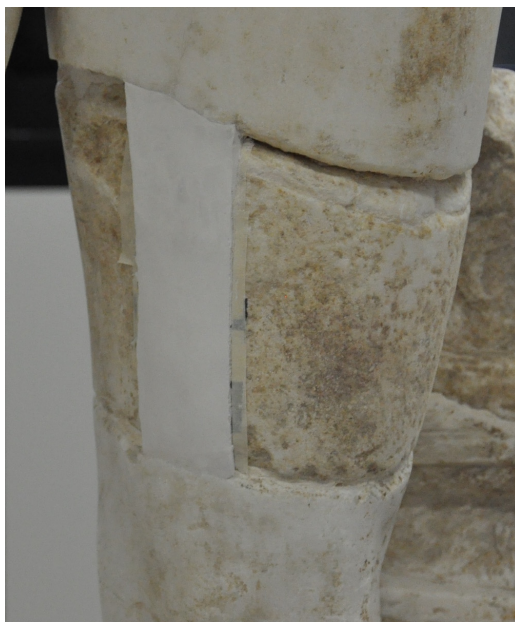
In the case of the left leg the restoration is more complicated. The additional fragment, is alteration from previous intervention. Probably it was located in the 17th century, but used also on the last interventions of the end of the 19th century.

Example of restoration with plaster on the left leg

Having the abovementioned in mind, the surface of the complement was isolated with tape and then a thin layer of plaster was located on top to see the aesthetic result. During this process it was noticed that the level of this additional part is a slightly lower than the other parts, and does not follow the exact geometry of the leg.

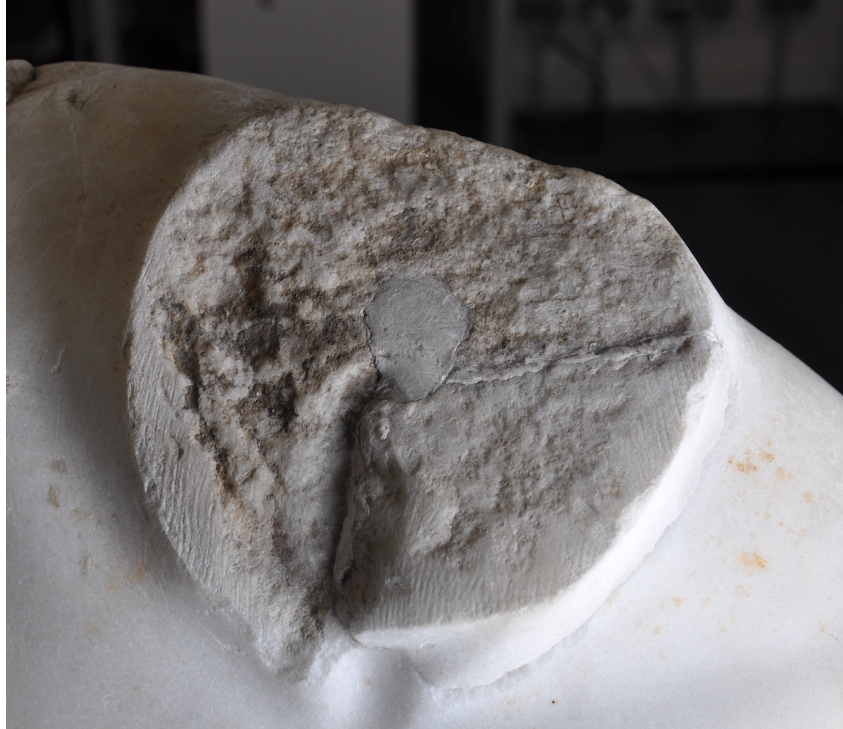
The attached fragment of the neck by G. Treu, does not appear in the drawings of 1804-1808. The material used to be attached are probably Sorel cement(?) with plaster sealing. The surface of the neck was elaborated with 'needle' and 'rasp' to fit the head complement. There is also the hole for the reinforcement, of the head, sealed with plaster. Probably this fragment broke during the removal of the head from the sculpture at the end of the 17th century.

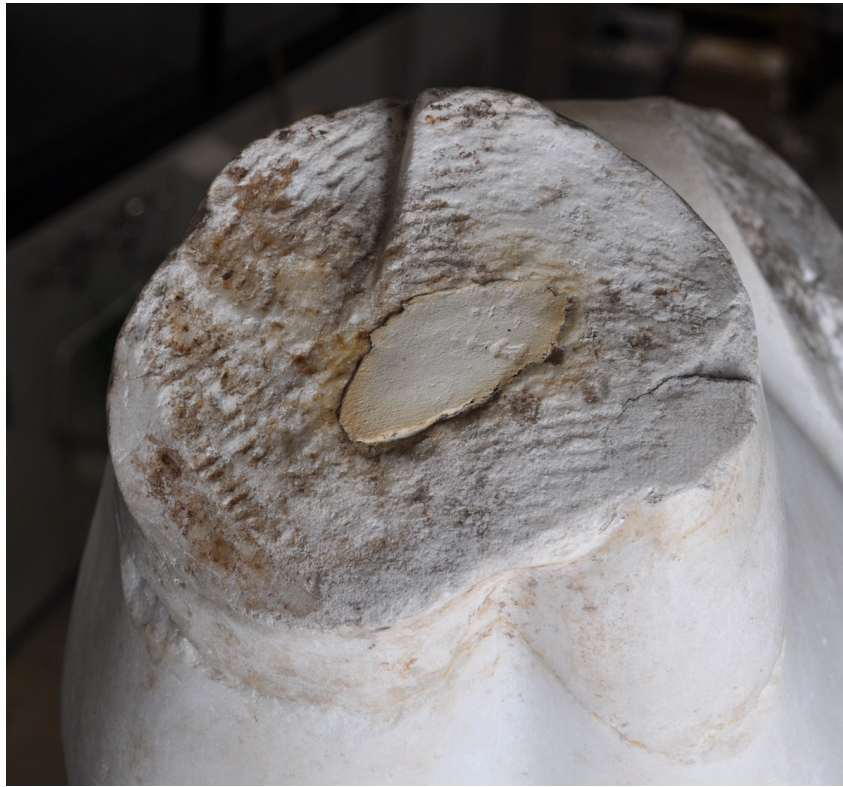
The attached fragment on the right shoulder also, does not appear as broken in the drawings of 1804-1808. The material used to be attached defers from the previous one. It is probably Colophony(?) and a mixture of Colophony and plaster as a sealing material. Probably colophony was the material of attaching the right arm complement, since traces of it revealed during the imaging with UV lights.

The surface was elaborated to fit the arm complement. The tooling traces in here indicate the use of 'tooth chisel' and 'rasp'. Similar to the neck, there is the hole to accommodate the reinforcement, sealed with plaster. The edges of the fragment are quite sharp, which indicates that it broke quite recent with the date of re-attachment.

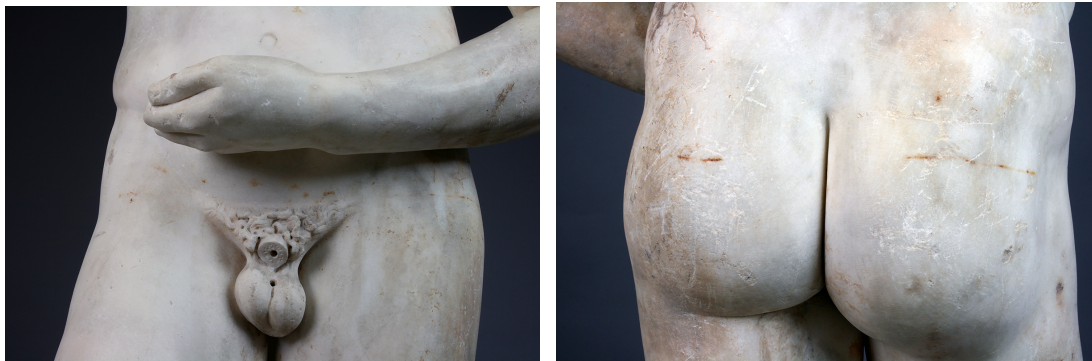
There is a continuous line of iron oxides in this level. Probably in the past they wanted to hold a cover for the groin, which should have probably remained for a long period. Also, in the same area there are two holes. The first one probably accommodated the reinforcement for a complement of the penis and the second for the vine leaf, which located at the 17th century.

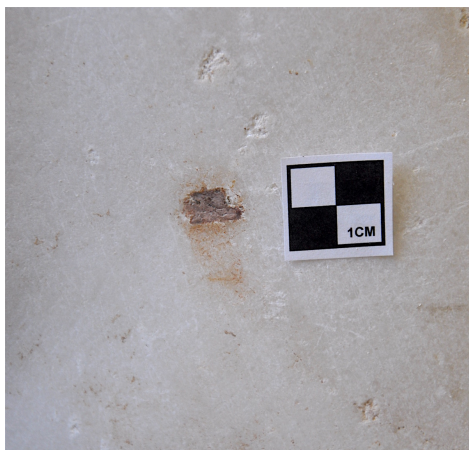
During the cleaning process were located some remains of clay(?) on the right leg. These traces are attributed to the molding for the cast production of the statue.

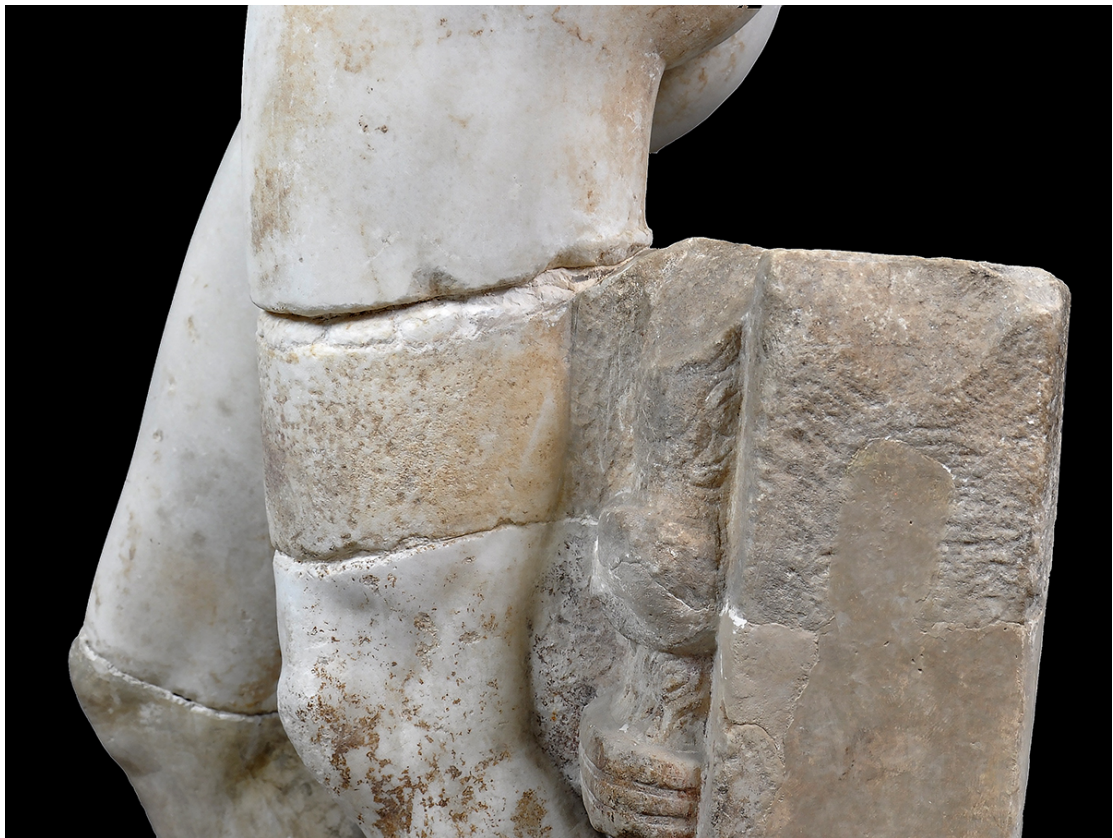
The upper part of this fragment, on the leg, seems that constitutes of many small pieces glued them together with Sorel(?) cement. Probably in this joint there was an iron reinforcement which had corroded from moisture and start to break the upper part of this fragment. This dowel was probably removed at the end of 19th century, and replaced by another. Or it was conserved.

The way of breaking is indication of a different material from the statue's marble. Especially if it is compered it with the crack on the upper part of the left leg.

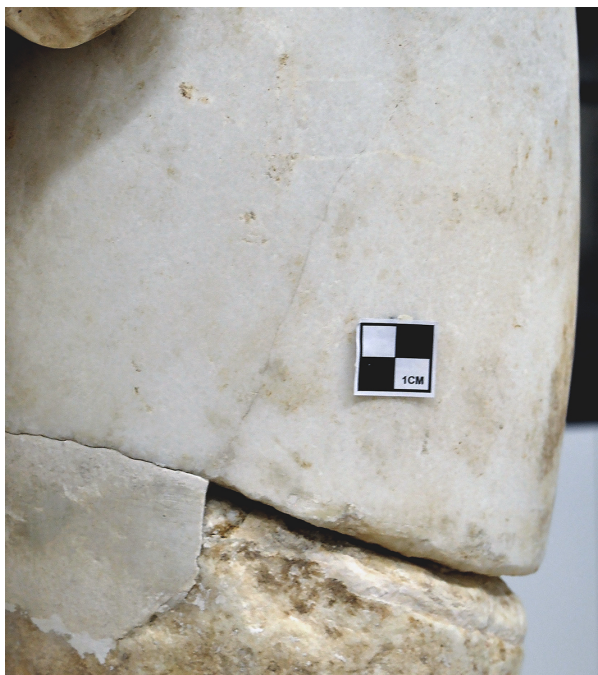
This crack was probably made from the same iron dowel. But since this material is harder, the level and the way of the crack differs significantly.

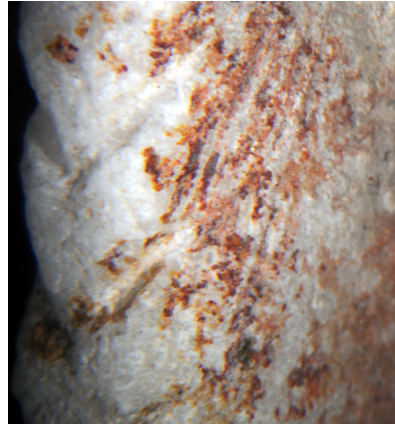
Stereomicroscope image of the string

Ancient red pigment (hematite?) was found on the pillar in the background of the aryballos but also on the two parts of string that hold it. This is probably remain of the sculpture's polychromy, but the same time indicates that the middle part of the pillar is ancient.

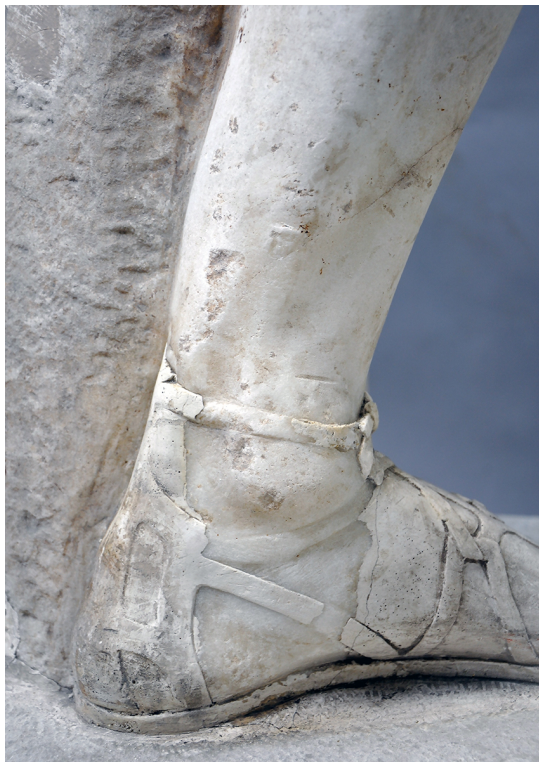
A trace of a tenon(?) to support the internal wing is also visible in the inner part of the left leg.

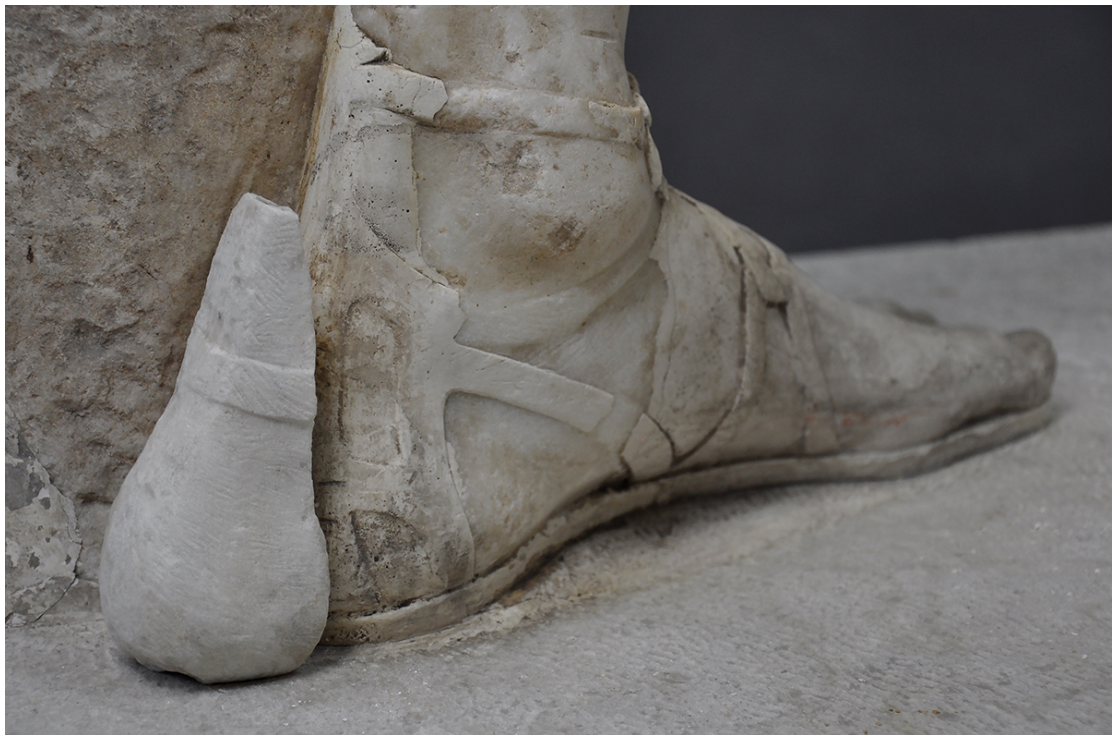
Under the astragal there are also tooling traces of a rasp. The same traces can be also found on the marble complement of the heel (Inv. Nr.: 277). This fragment was probably removed by G. Treu. The 'rasp' traces in both the sculpture and the complement, indicate that the final 'Shaping' of the last was given, when it was attached into the sculpture.

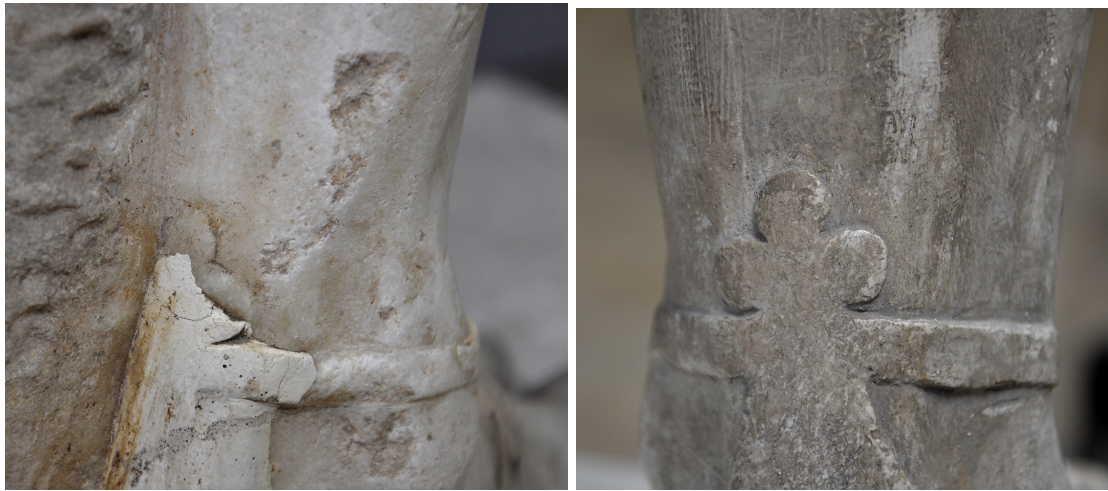
The remain of this motive in the shape of a clover, from the left heel not visible under the plaster, was copied to the right leg complement.
