Conservation of a Standing Male Sculpture (Athlete)

Report of Constantinos Vasiliadis
SKD Research Fellowship 2015
(24 Oct. – 22 Nov. 2015)

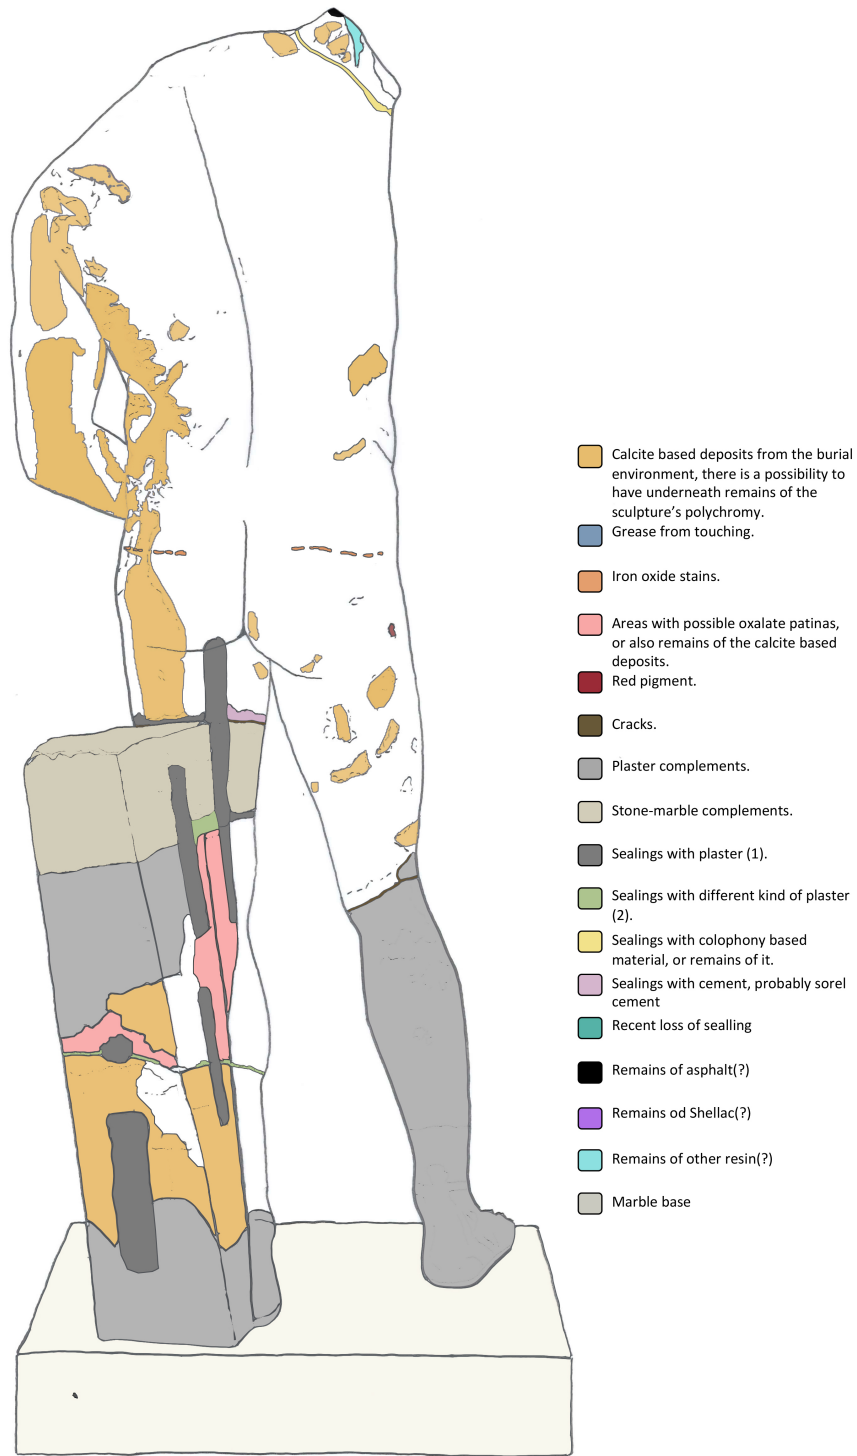
Mapping drawing of the back side

- Calcite based deposits from the burial environment, there is a possibility to have underneath remains of the sculpture's polychromy.
- Grease from touching.
- Iron oxide stains.
- Areas with possible oxalate patinas, or also remains of the calcite based deposits.
- Red pigment.
- Cracks.
- Plaster complements.
- Stone-marble complements.
- Sealings with plaster (1).
- Sealings with different kind of plaster (2).
- Sealings with colophony based material, or remains of it.
- Sealings with cement, probably sorel cement
- Recent loss of sealling
- Remains of asphalt(?)
- Remains of Shellac(?)
- Remains of other resin(?)
- Marble base

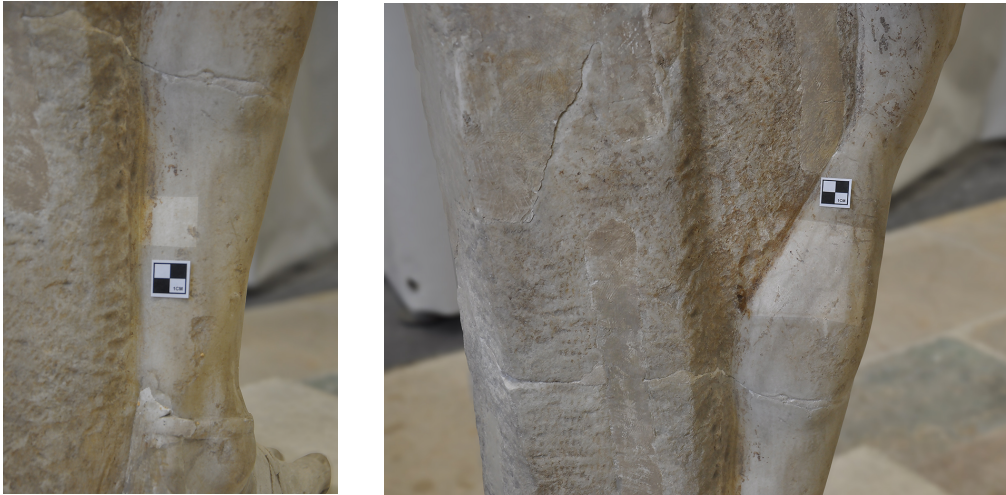
Cleaning tests: On the left photo with soft eraser and on the right with blotting paper compress, saturated in tap water

From these tests it should be noted that cleaning was made much easier with the application of water-compress and then swab. Deionized water was avoided since it would be too aggressive instead, tap water was used. In some areas, difficult to be cleaned, the compress was repeated for more times.

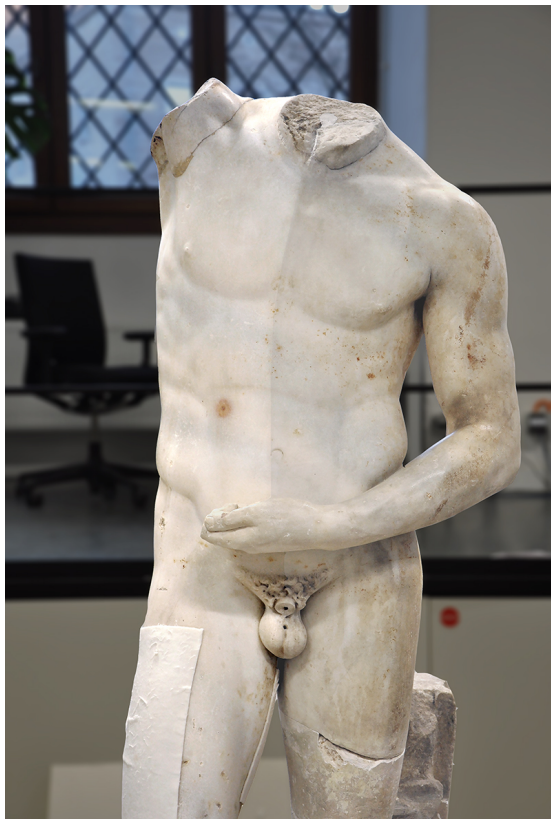
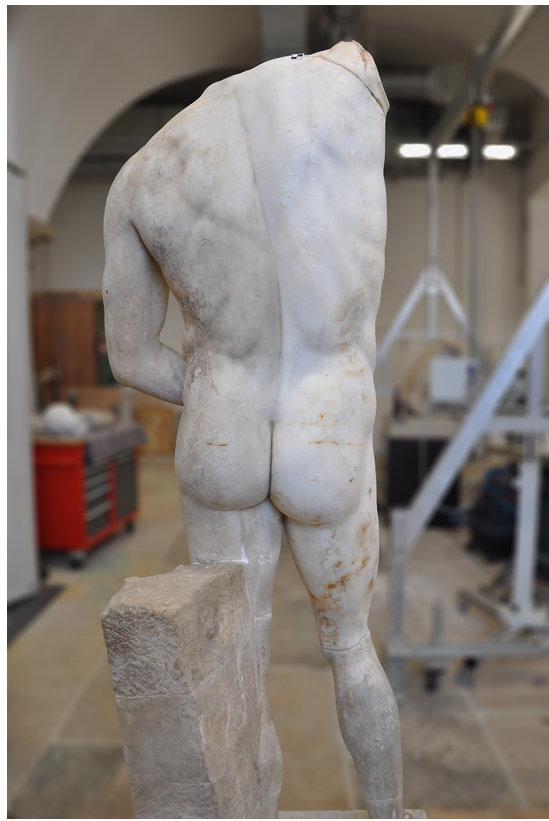
During the cleaning process, with the left part of the statue cleaned

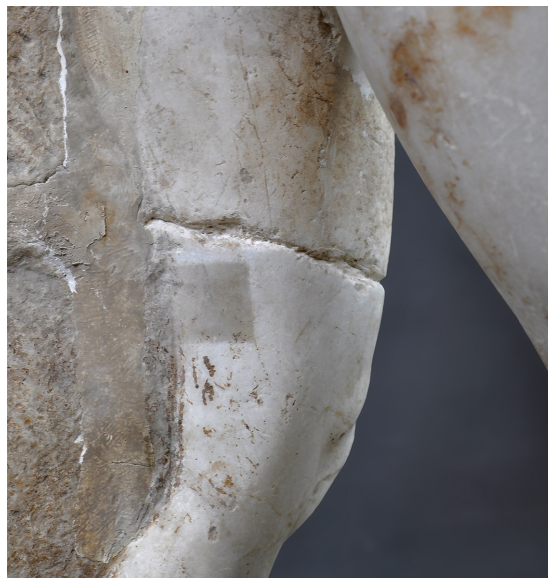
The reference surface of the condition before treatment, on the inner part of the left leg

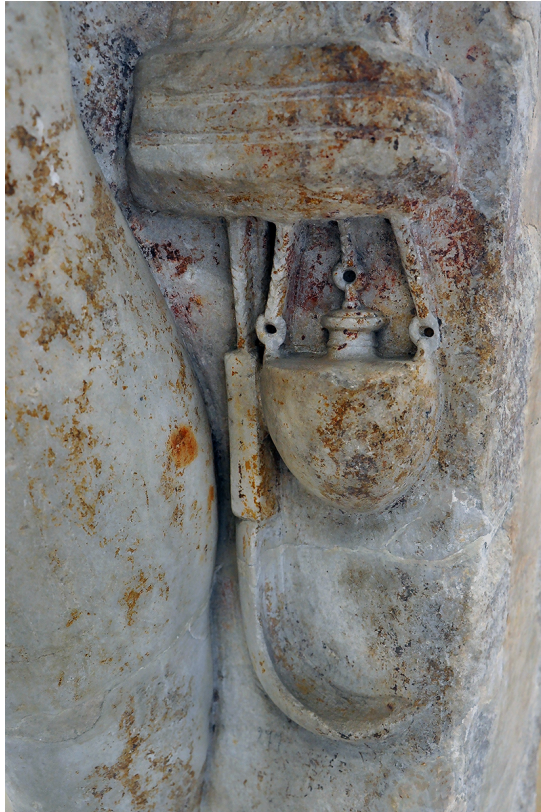
Ancient red pigment (hematite?) was found on the pillar in the background of the aryballos but also on the two parts of string that hold it. This is probably remain of the sculpture's polychromy, but the same time indicates that the middle part of the pillar is ancient.

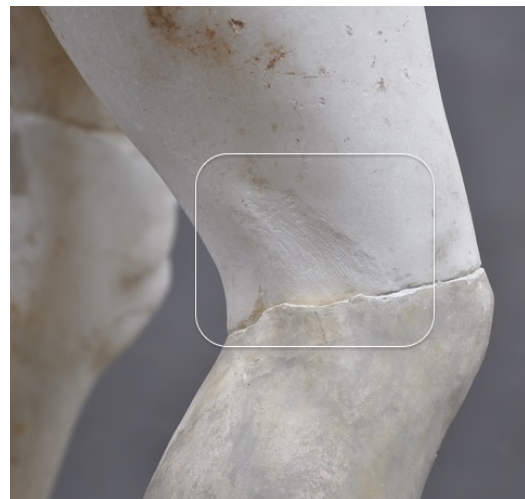
On the right leg, the loss of marble mass and of sculptured details as well as tooling traces of a rasp, show that this part was elaborated to attach the leg and the second pillar.

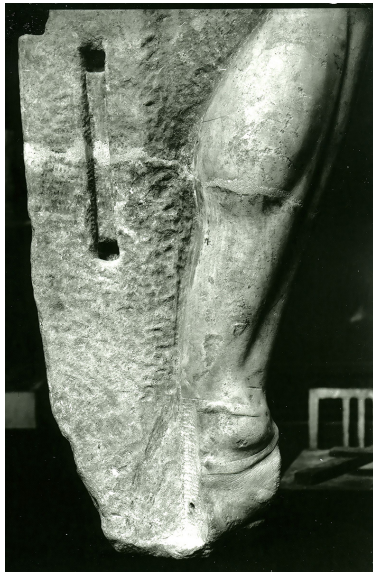
Hm-067-Neg-432

This is the photo from G. Treu interventions, where this complement has been removed but the hole of the reinforcement exists. There is also a cutting on the marble, probably to accommodate the complement. This space was covered by a plaster complement.

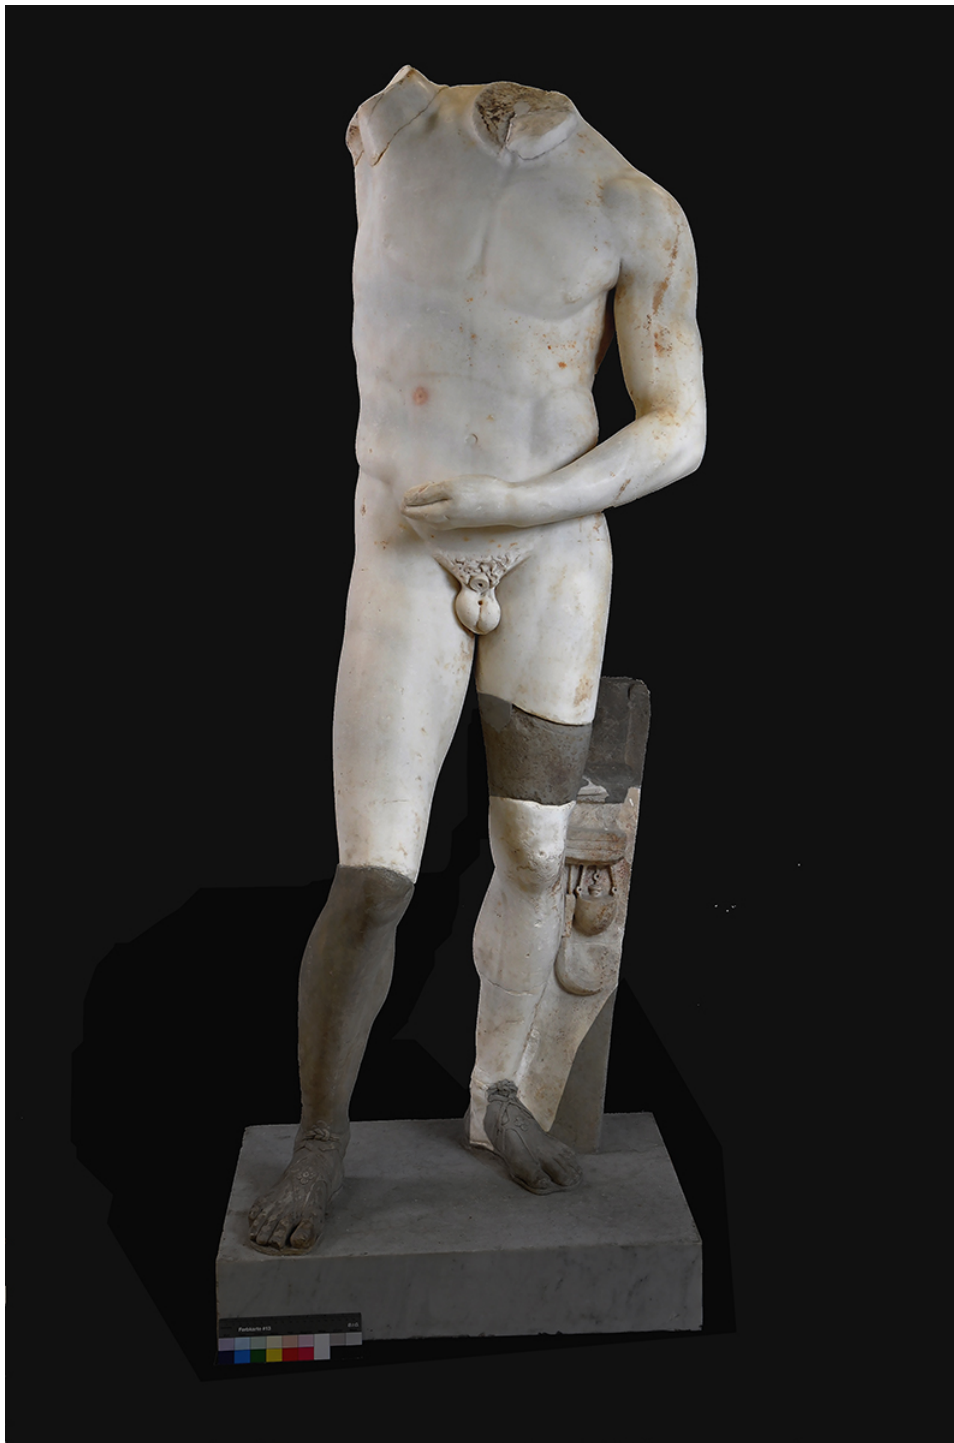
Examining the main characteristics of the marble, there were noted the following:

- Fine and uniform grain size.
- No porosity
- White color, a bit orange in places where the original patina is preserved
- Gray veins, visible after cleaning.

All the abovementioned suggest that the marble is probably originated from Penteli mountain in Attica - Greece.

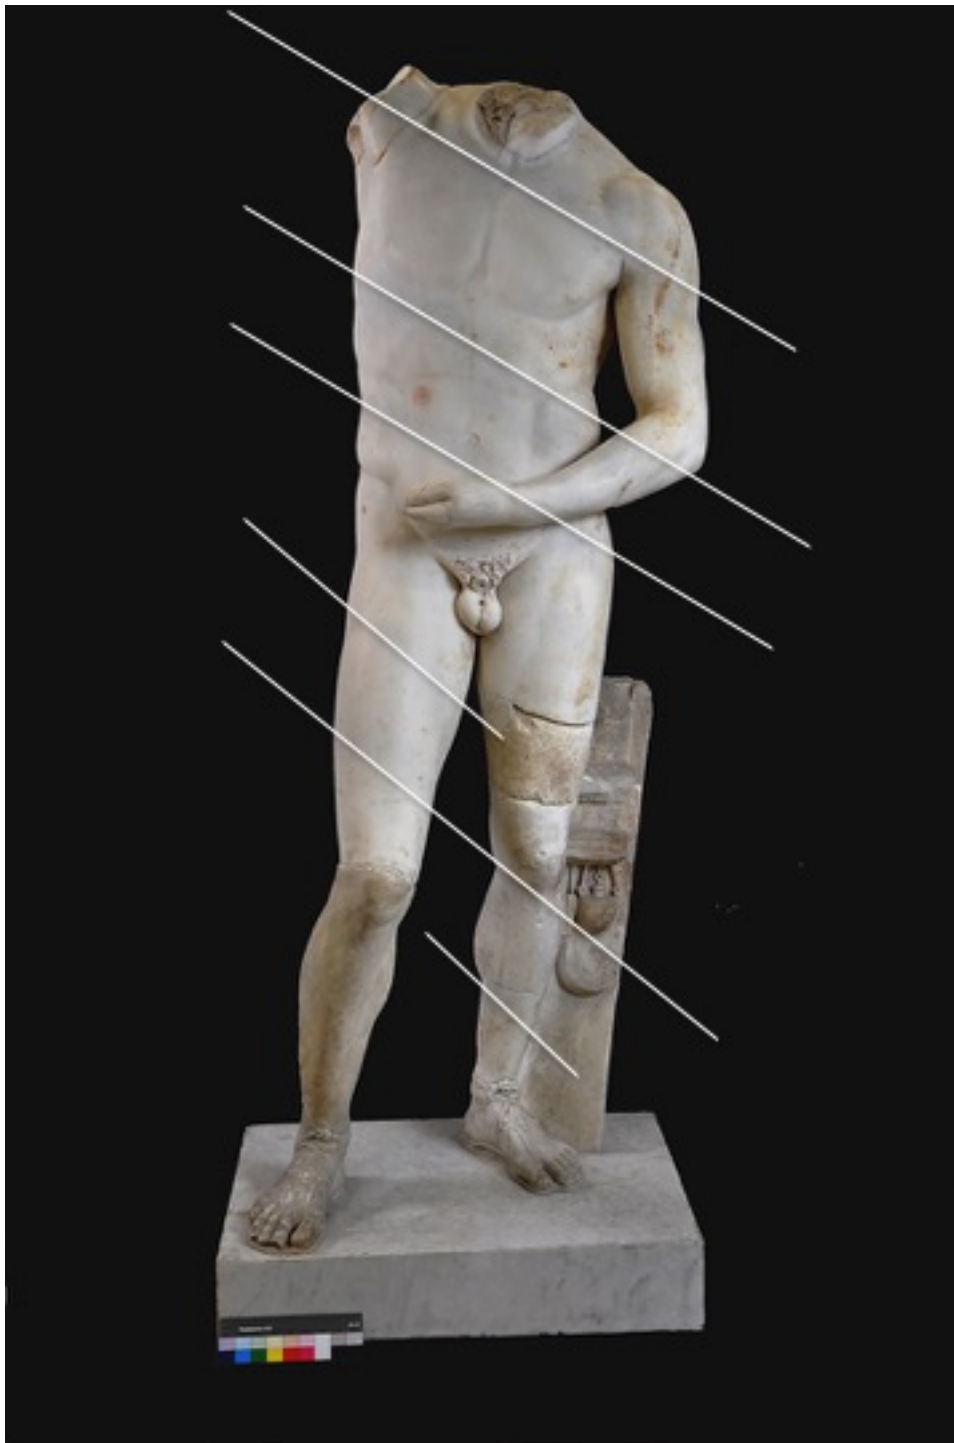
The use of the marble veins appeared in diagonal direction. From the right side of the statue (up) to the left side (down). This structure indicates the following:

- The left leg with the pillar belongs to the statue, since the same veins are answered below the knee.
- The volume of the statue was oriented in a way so as to give the strong part of the marble into the extend right arm. So the arm (at least up to the angle) should have followed the direction of the veins. Its broke caused from a violent incident, probably failure.
- This suggests that the whole structure was probably built from one block of marble, with no additional parts (arm and head).
